## **Planning Environment and Services Committee**

Inspected: 4-May-2023 - 07:23 by Robert Walters RPII Annual Inspectors

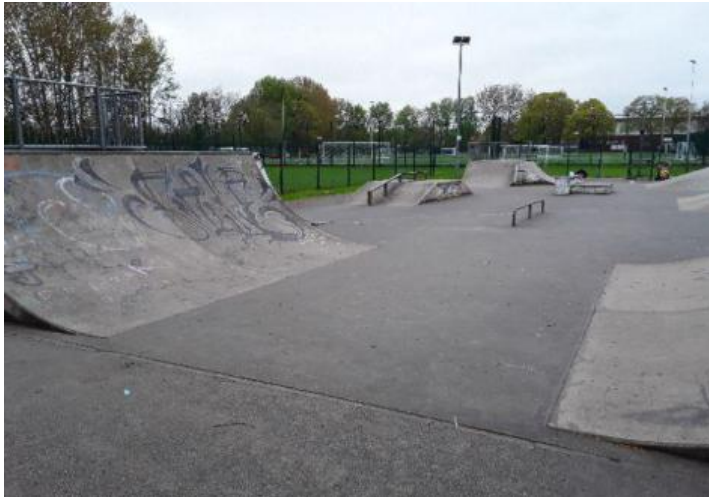
**Finding:** Signage of the wheeled sports area should be provided as recommended in BS EN 14974; this will include, but not exclusively, the use of the area, a recommendation to wear protective equipment, emergency contact details etc.

**Action:** Provide signage as recommended by BS EN 14974 for wheeled sports areas

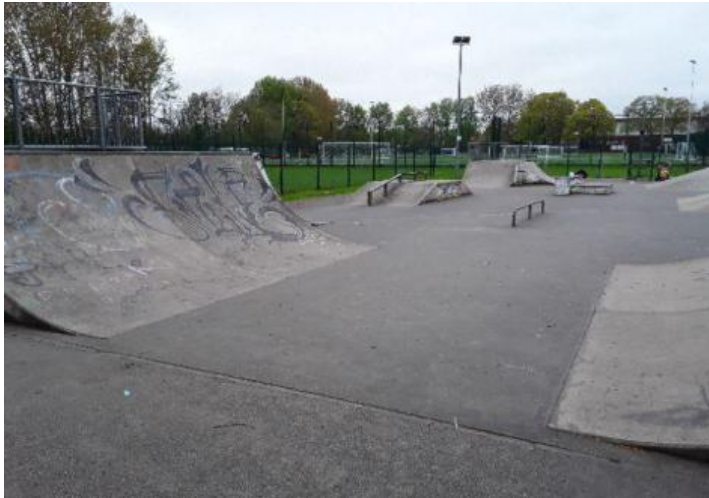
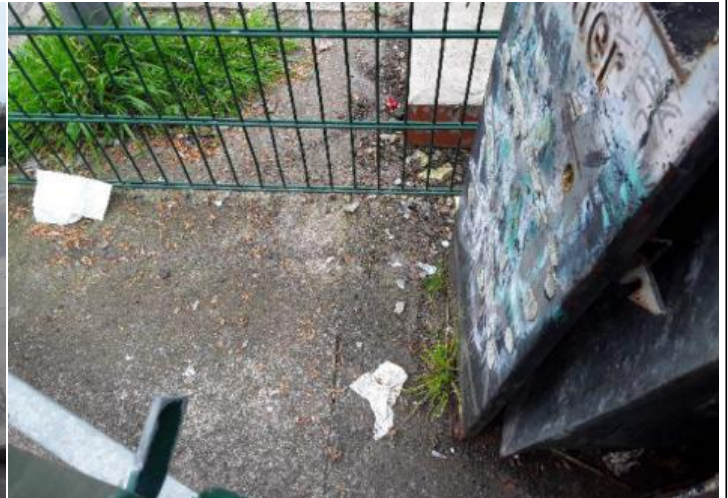
**Finding:** There is broken glass present on site

**Action:** Remove the broken glass and maintain the area

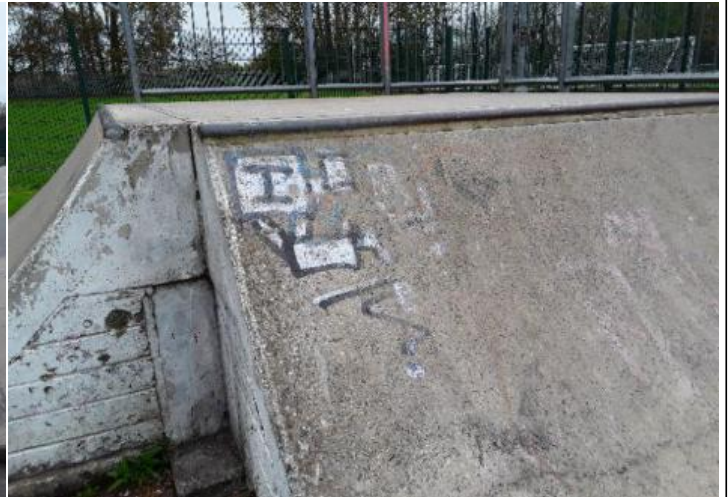
**Finding:** There is some graffiti present

**Action:** Remove the graffiti

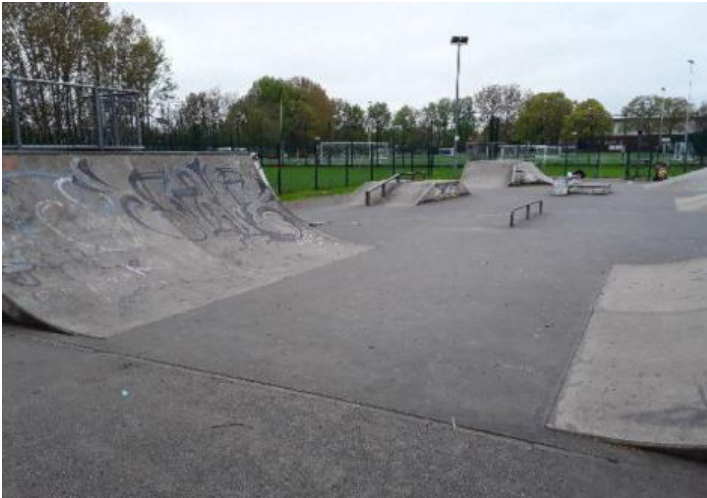
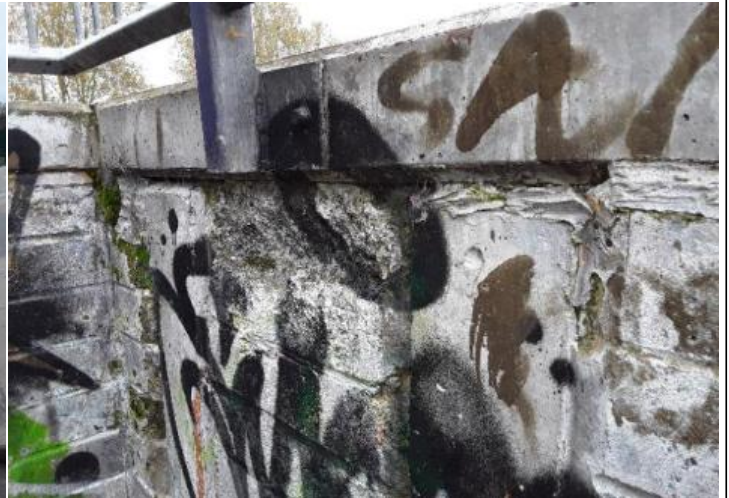
**Finding:** There is damage to the brickwork

**Action:** Repair affected areas

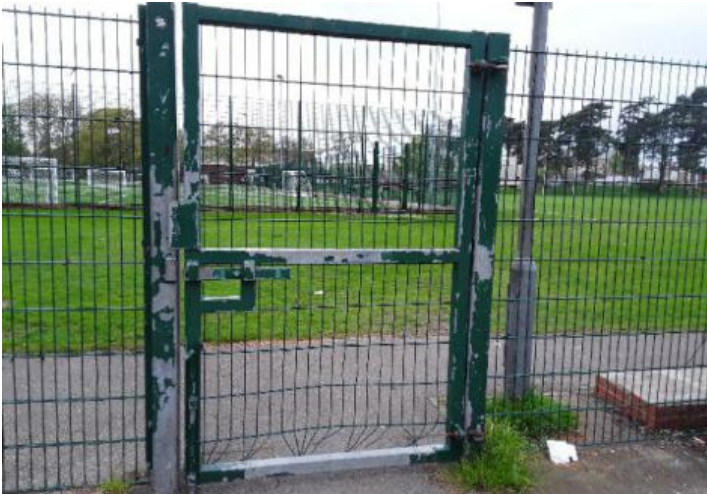
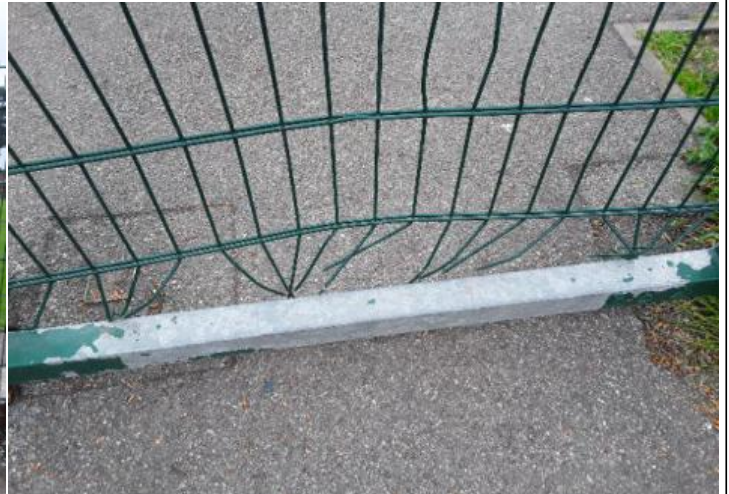
**Finding:** The gate is damaged in places

**Action:** Repair or replace all affected sections

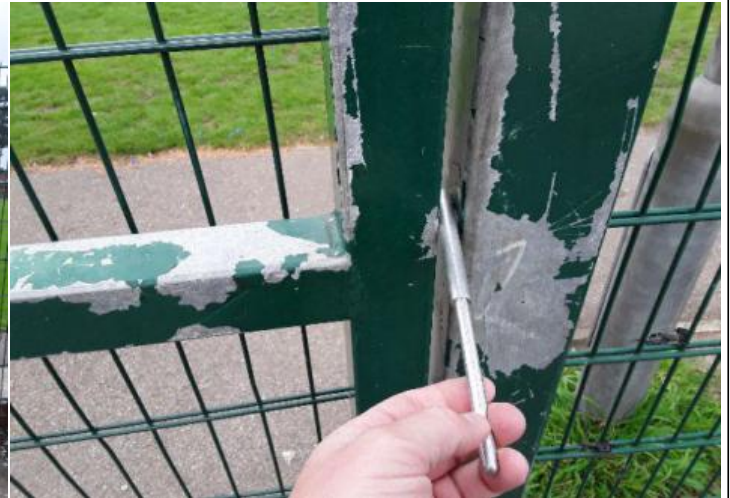
**Finding:** There are openings that are less than 12mm that could trap or crush fingers

**Action:** Provide a 12mm gap throughout full range of motion at both sides of gate

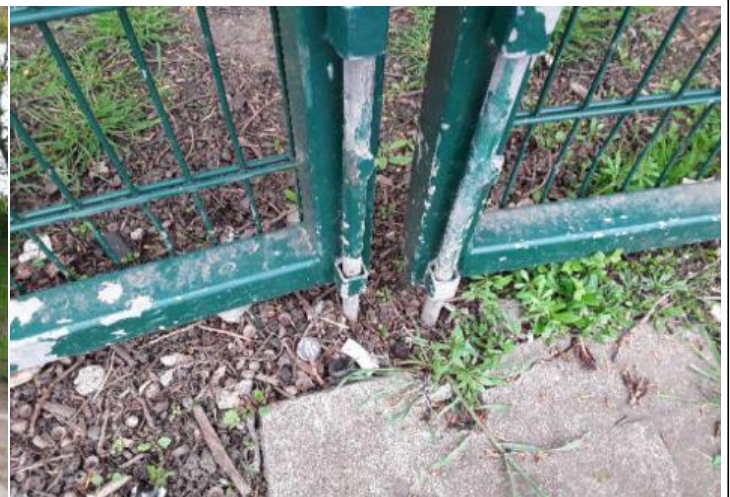
**Finding:** The gate has no drop bolt sleeves and/or drop bolts fitted

**Action:** Provide drop bolt sleeves and/or drop bolts

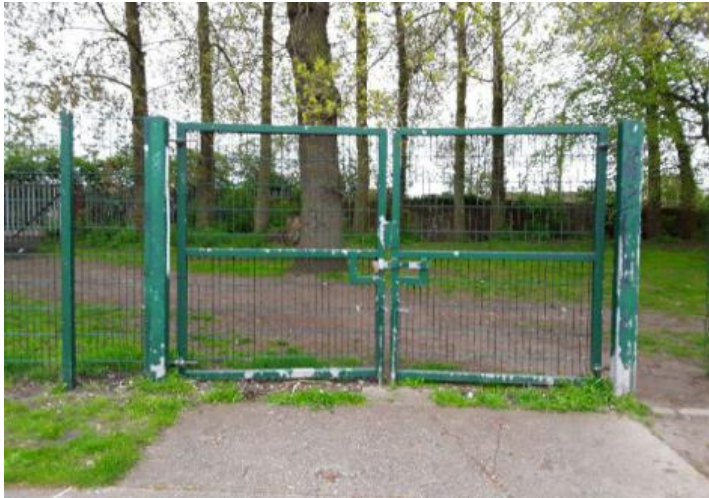
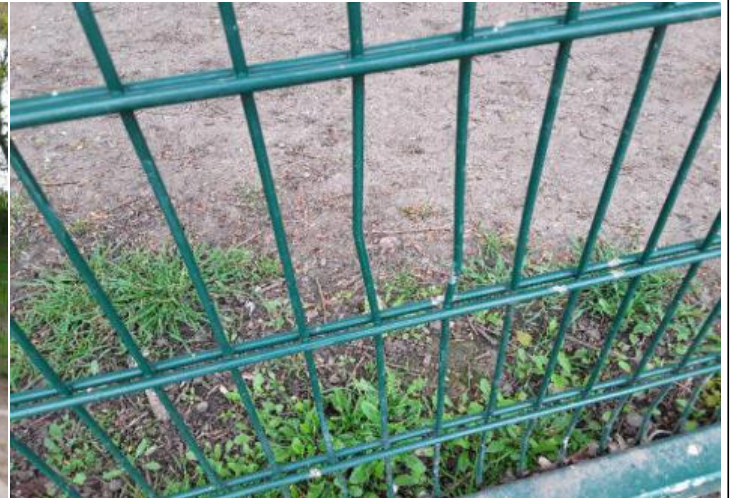
**Finding:** There is some damage to the item

**Action:** Monitor for any further deterioration and repair as required

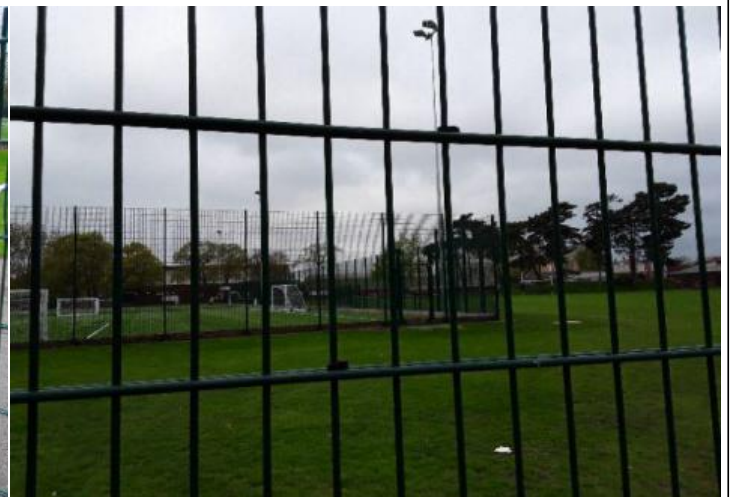
**Finding:** There are redundant cable ties present

**Action:** Remove

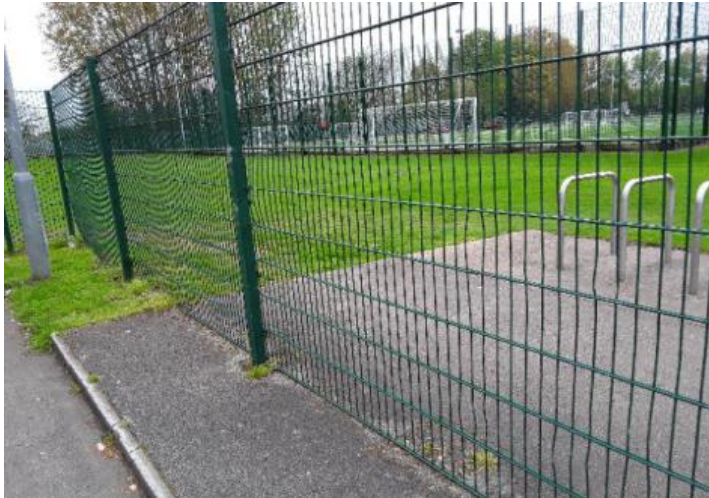
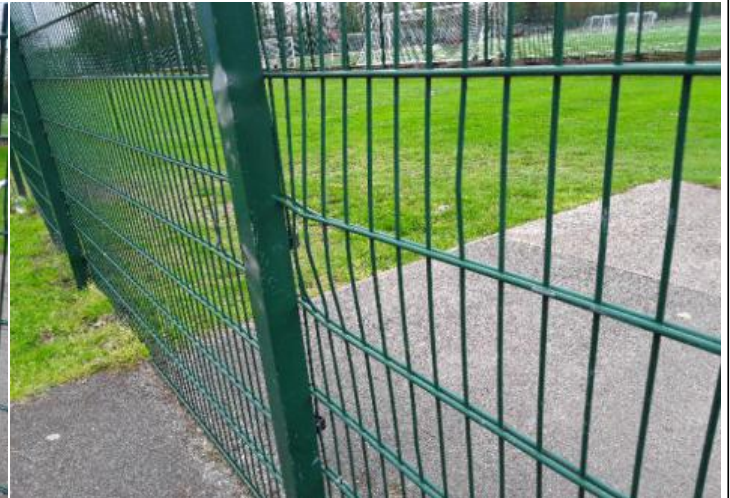
**Finding:** There is some damage to the fence sections

**Action:** Monitor for any further deterioration and repair as required

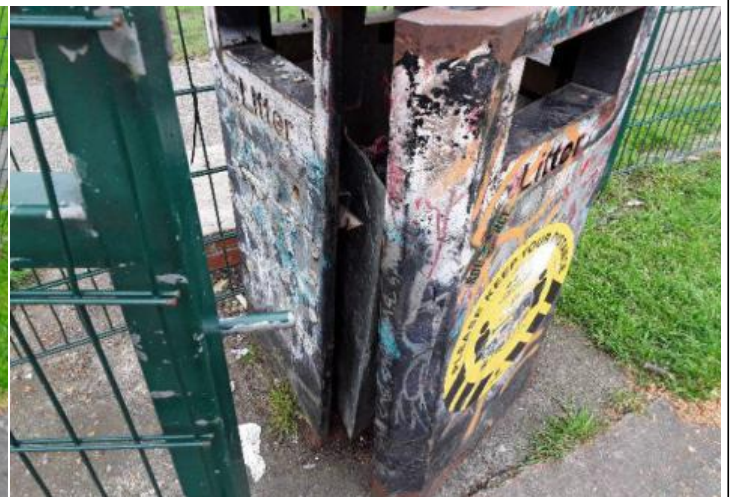
**Finding:** The lid or door of the litter bin is not secured

**Action:** Ensure the lid or door is kept locked

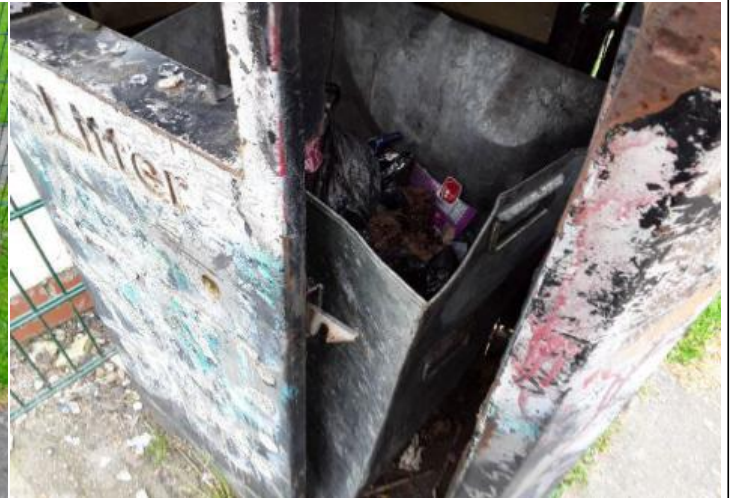
**Finding:** The liner of the litter bin is not secured

**Action:** Ensure the lid/door is kept locked and the liner secured

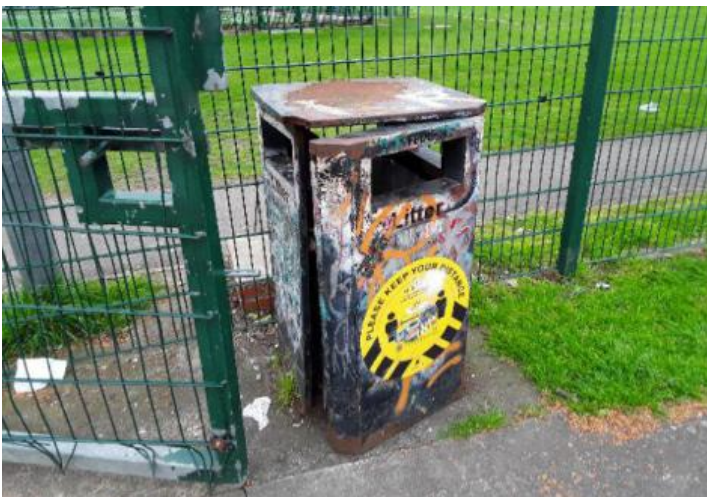
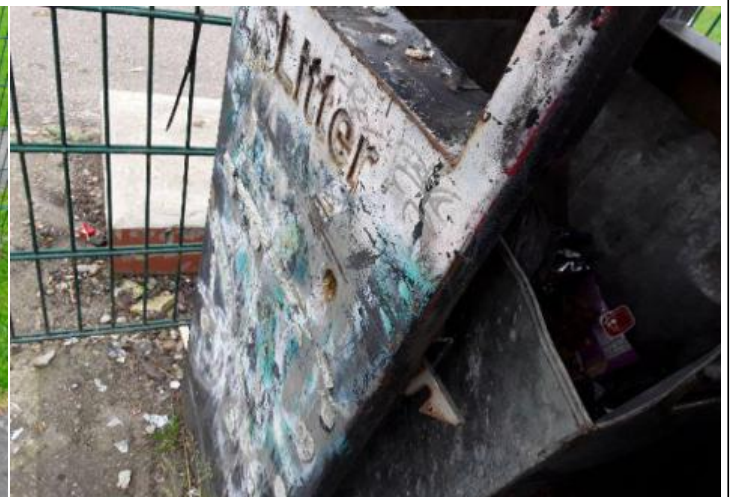
**Finding:** There is some evidence of fire damage to the item

**Action:** Monitor for any further deterioration and repair as required

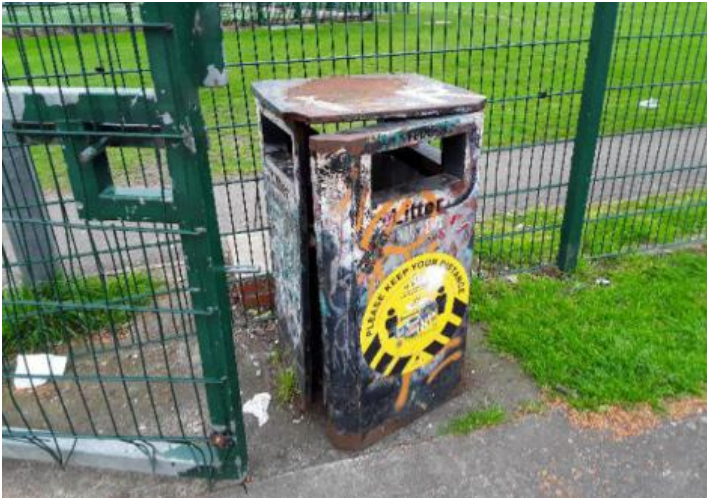
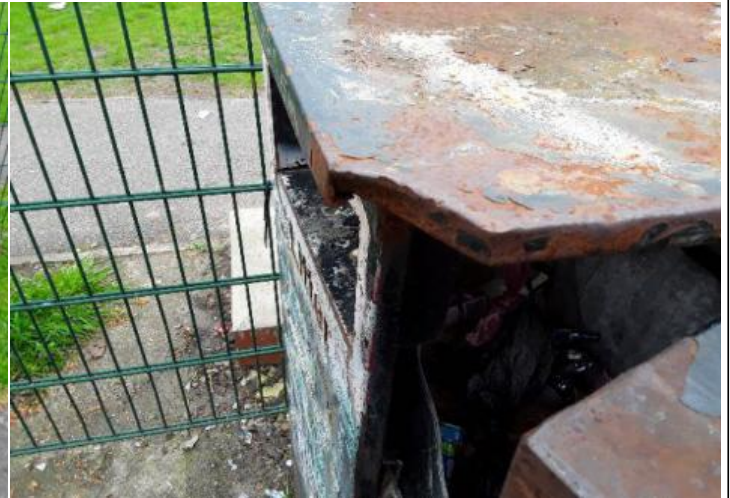
**Finding:** There is some damage to the item

**Action:** Monitor for any further deterioration and repair as required

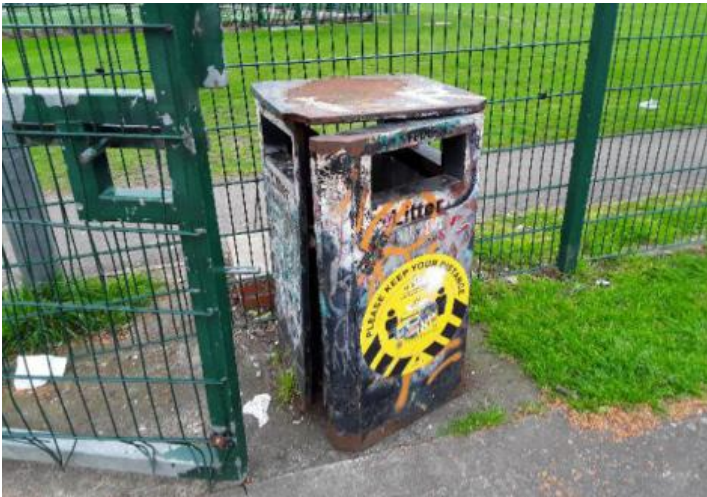
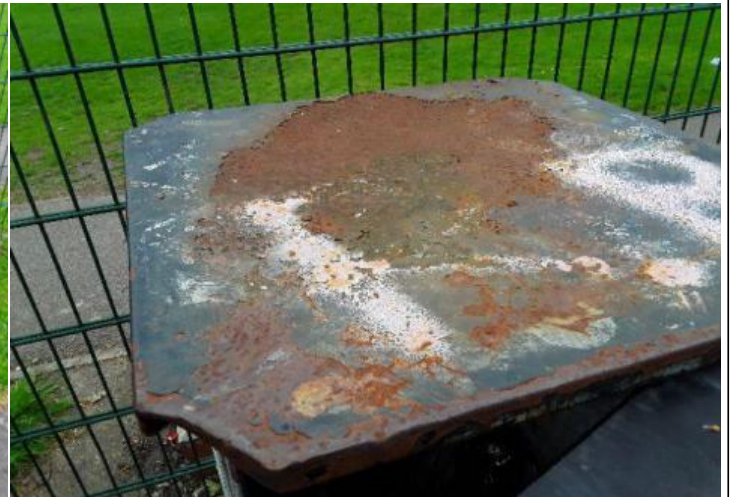
**Finding:** There is surface corrosion present on the item

**Action:** Consider treating the item

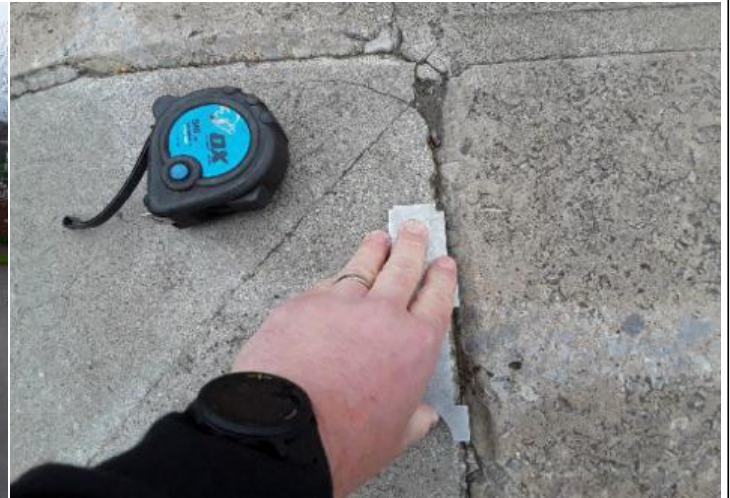
**Finding:** Joints between the riding surfaces should not be greater than 5mm to meet the requirements of BS EN 14974  
**Action:** Take corrective action to ensure that the gaps between the joints do not exceed 5mm

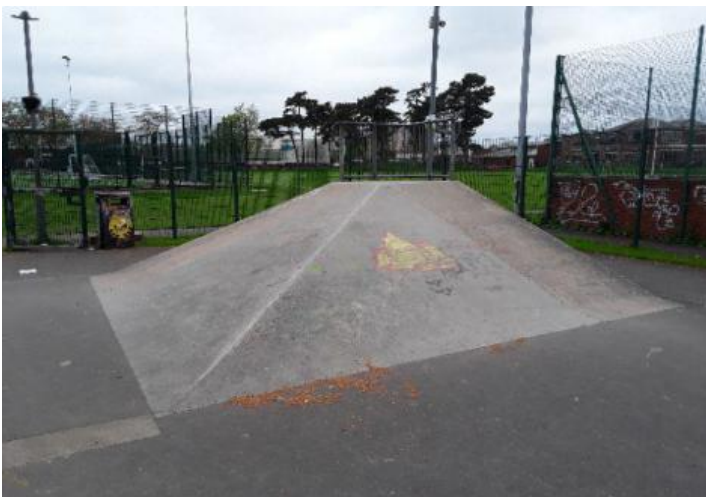
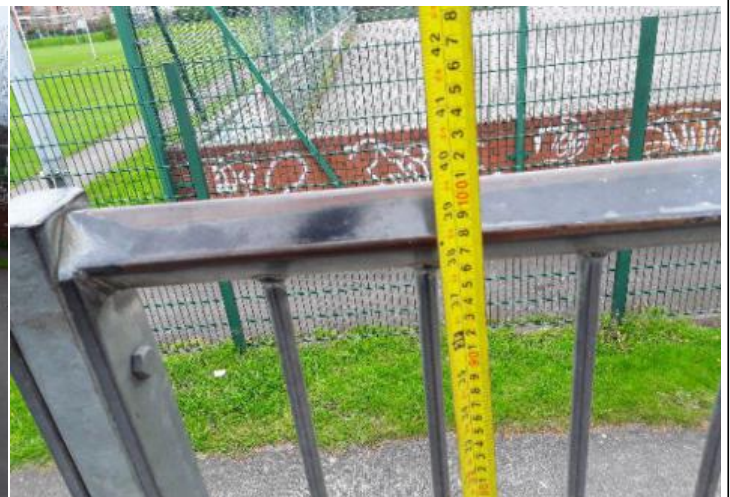
**Finding:** The height of the barrier is less than 1200mm and fails the requirements of BS EN 14974  
**Action:** Monitor - No remedial work recommended

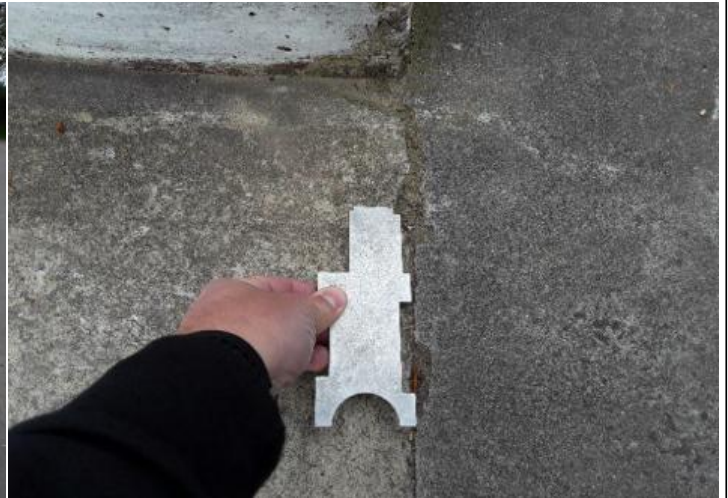
**Finding:** Joints between the riding surfaces should not be greater than 5mm to meet the requirements of BS EN 14974  
**Action:** Take corrective action to ensure that the gaps between the joints do not exceed 5mm

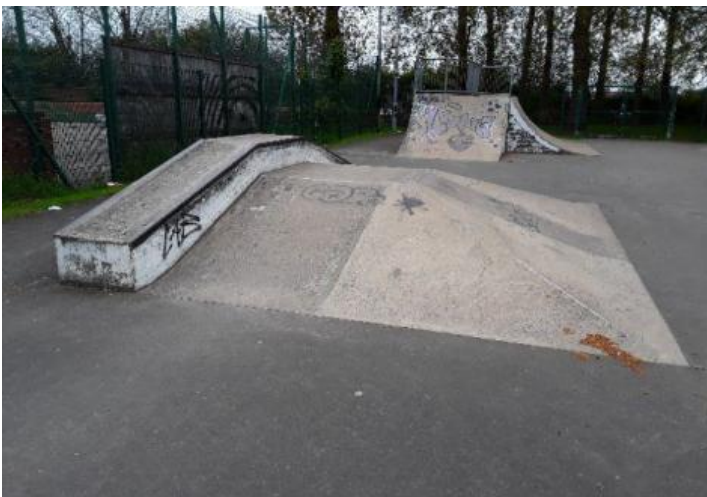
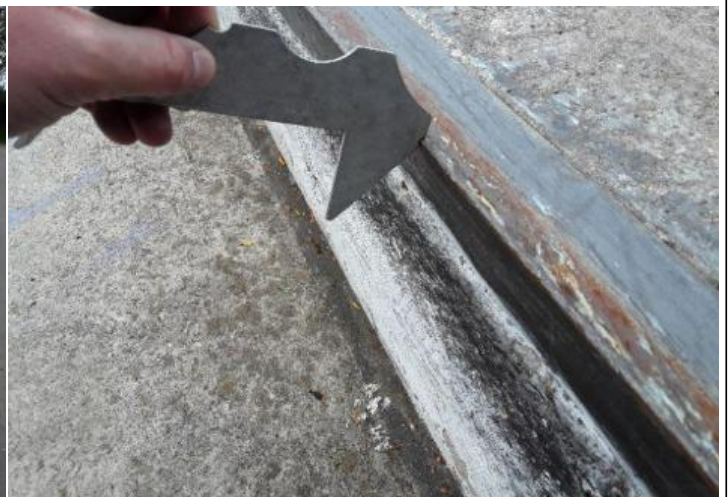
**Finding:** The item has exposed edges and corners with a radius of less than 3mm and fails the requirements of BS EN 14974  
**Action:** Monitor - no remedial action recommended

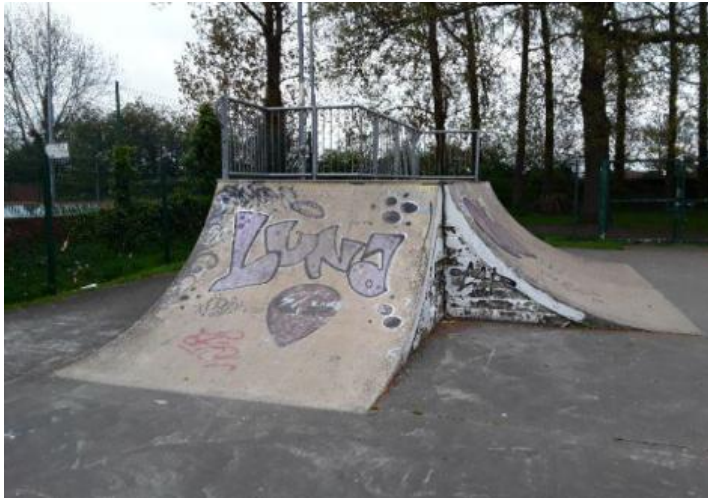
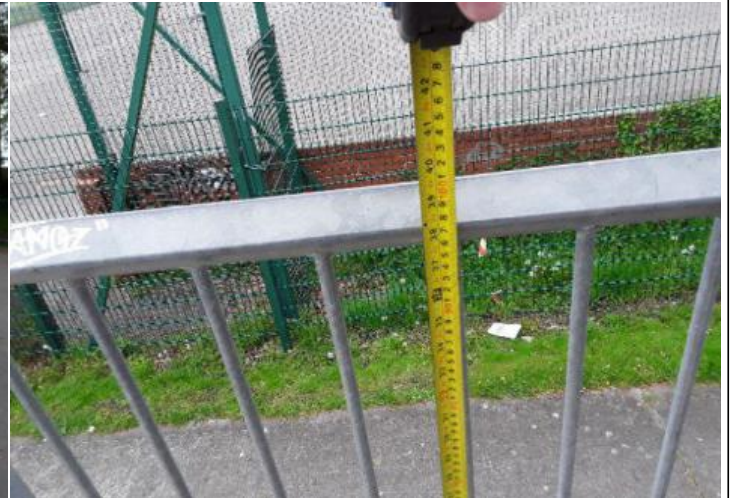
**Finding:** The height of the barrier is less than 1200mm and fails the requirements of BS EN 14974  
**Action:** Monitor - No remedial work recommended

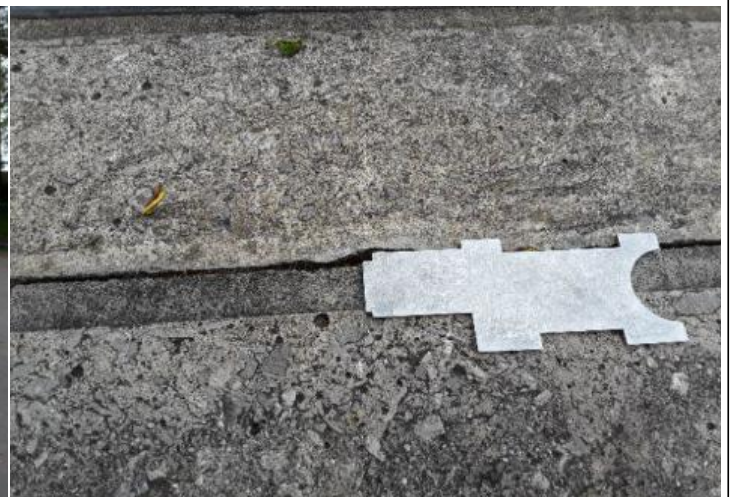
**Finding:** Joints between the riding surfaces should not be greater than 5mm to meet the requirements of BS EN 14974  
**Action:** Take corrective action to ensure that the gaps between the joints do not exceed 5mm

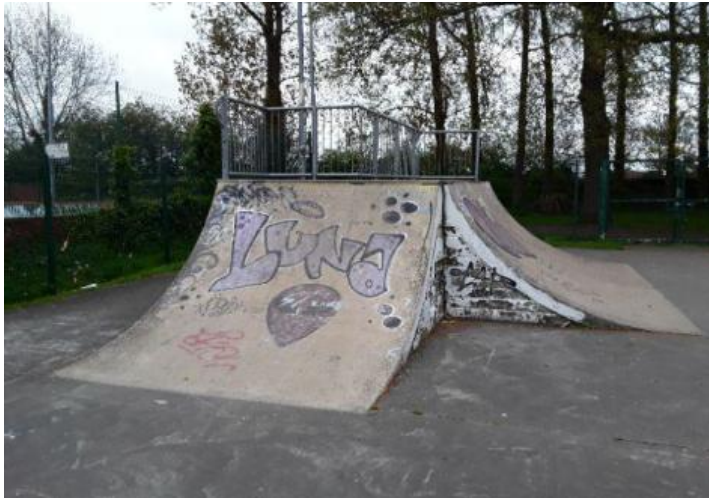
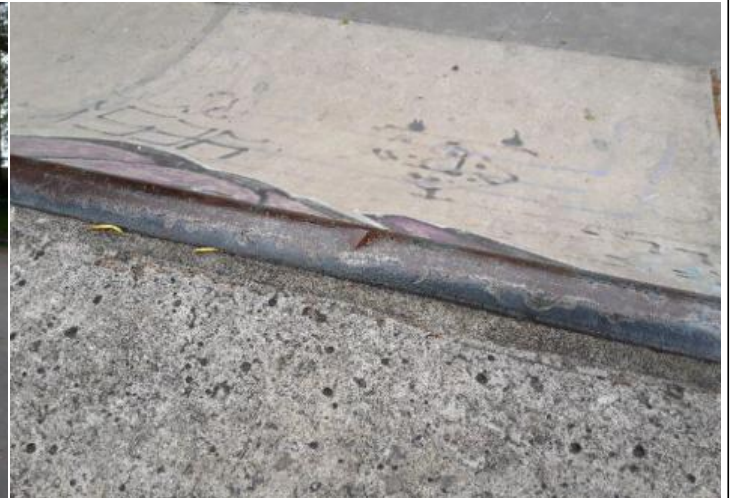
**Finding:** The coping has been damaged

**Action:** Monitor for any further deterioration and replace as required

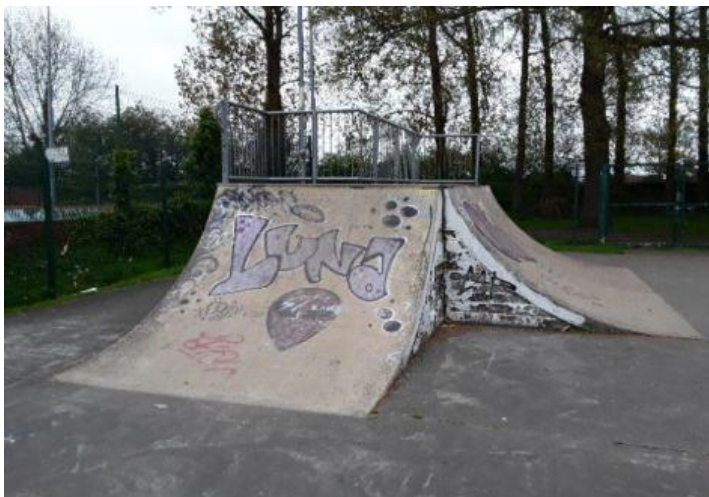
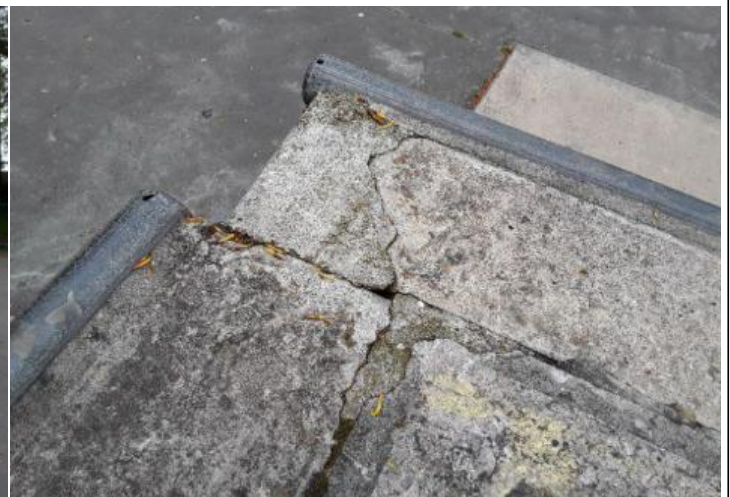
**Finding:** The riding surface of the platform has some damage apparent

**Action:** Monitor for any further deterioration and repair as required

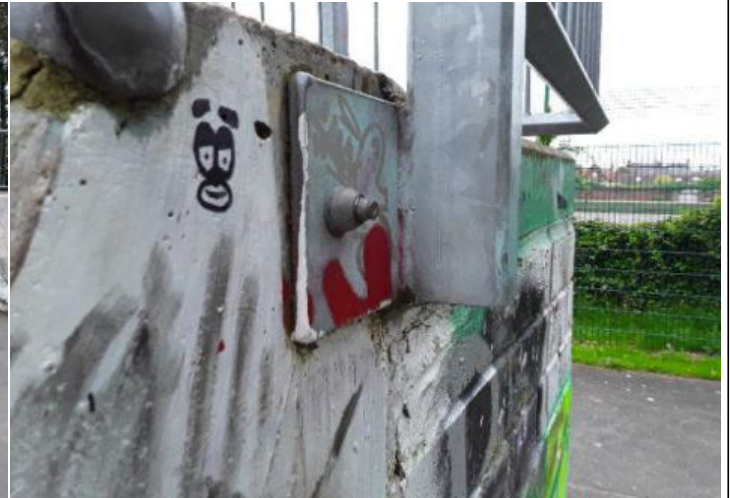
**Finding:** There are projecting bolt thread(s) present

**Action:** Remove excess thread length and deburr or provide cap

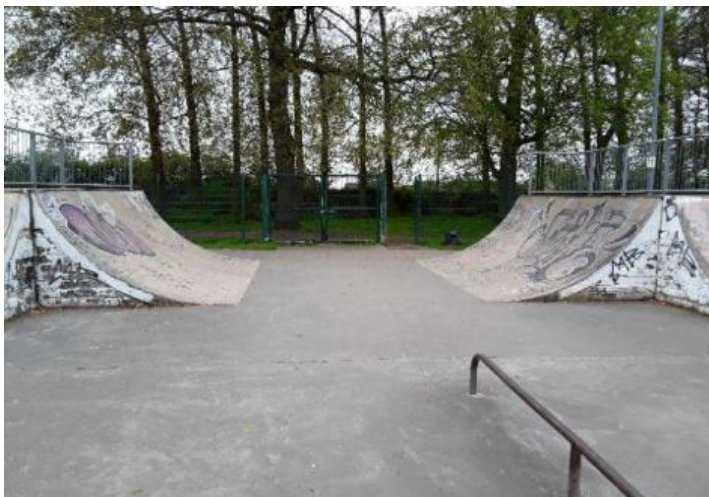
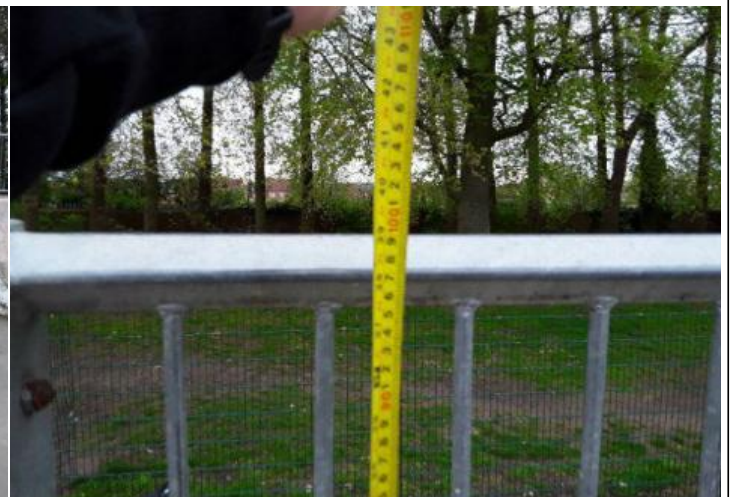
**Finding:** The height of the barrier is less than 1200mm and fails the requirements of BS EN 14974

**Action:** Monitor - No remedial work recommended

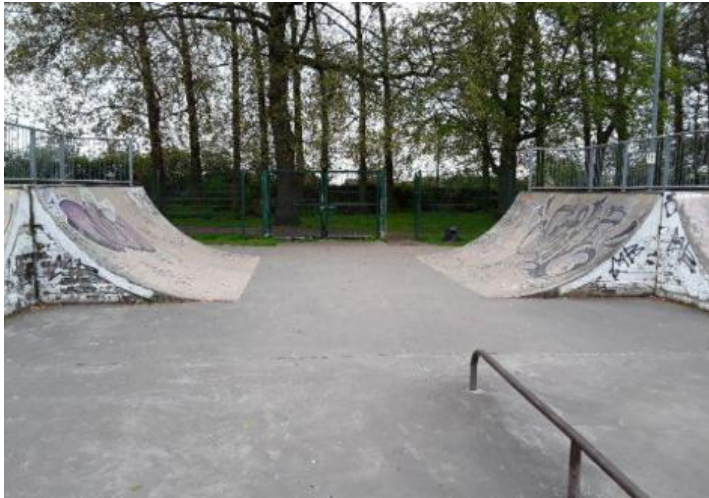
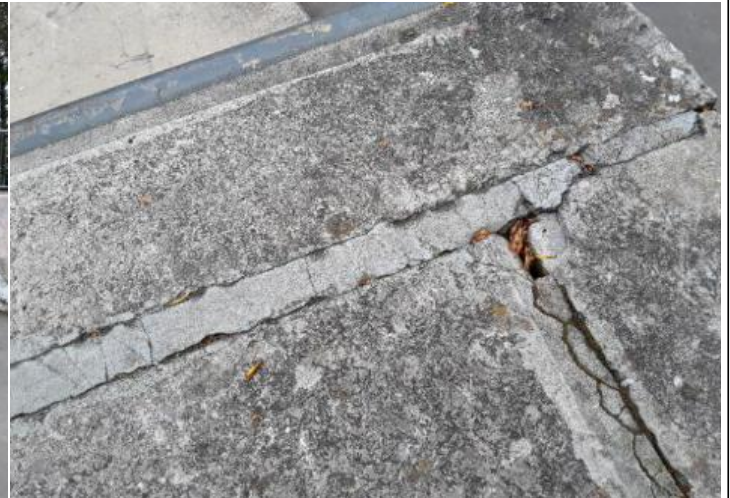
**Finding:** The riding surface of the platform has some damage apparent

**Action:** Repair the affected areas

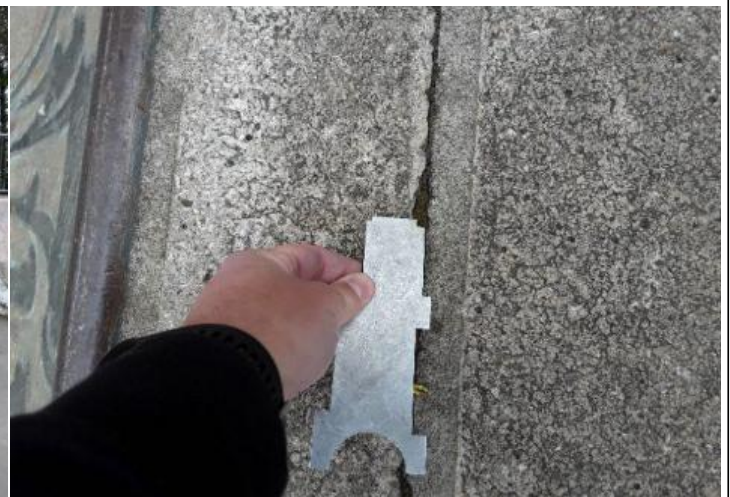
**Finding:** Joints between the riding surfaces should not be greater than 5mm to meet the requirements of BS EN 14974

**Action:** Take corrective action to ensure that the gaps between the joints do not exceed 5mm

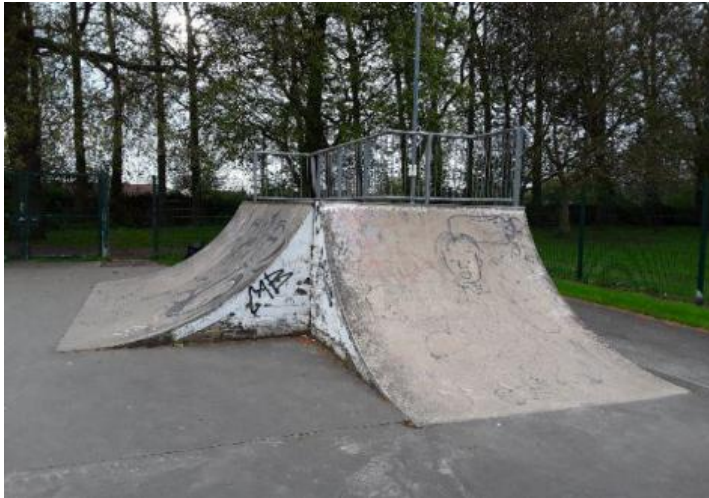
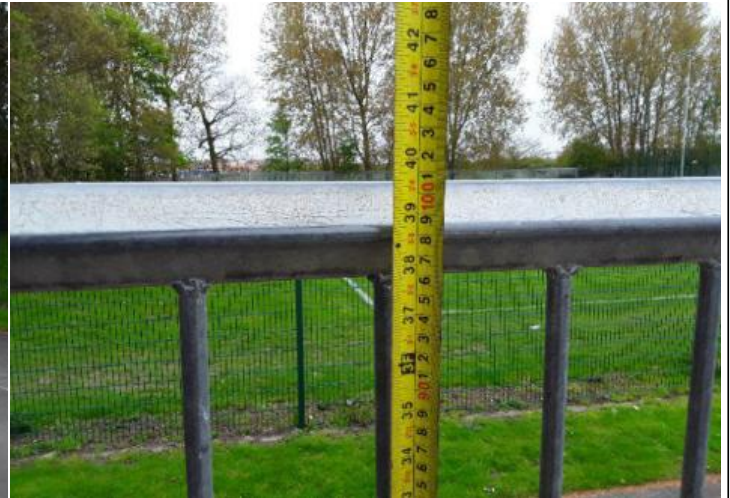
**Finding:** The height of the barrier is less than 1200mm and fails the requirements of BS EN 14974

**Action:** Monitor - No remedial work recommended

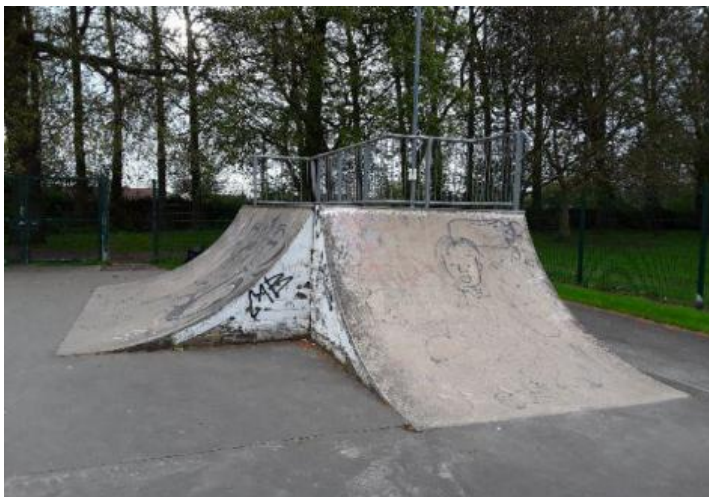
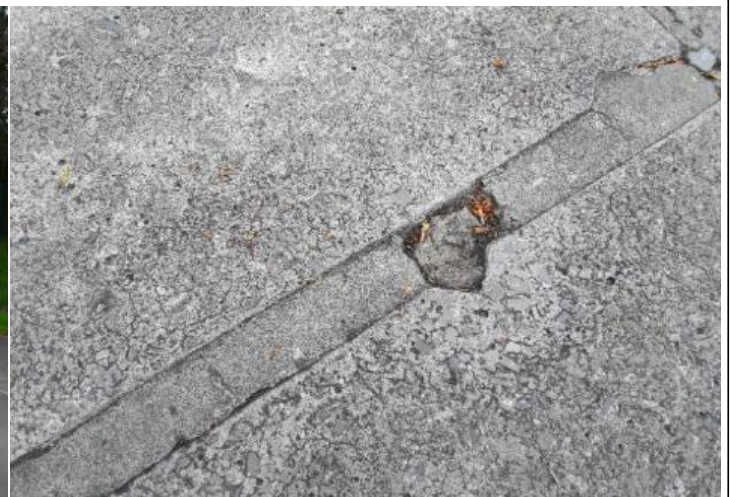
**Finding:** The riding surface of the platform has some damage apparent

**Action:** Repair the affected areas

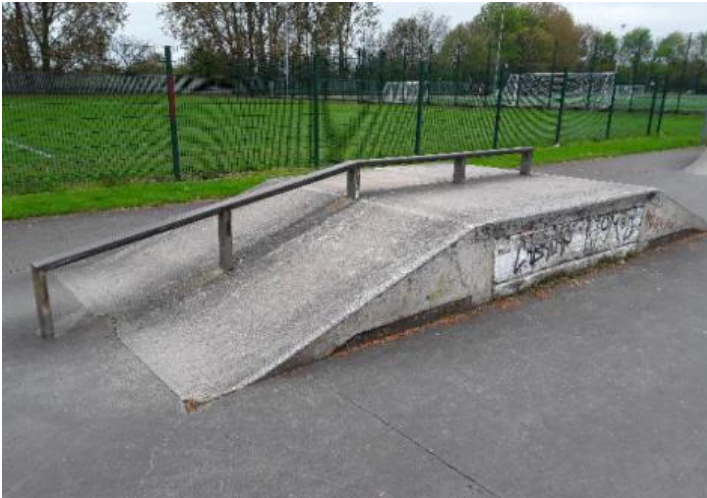
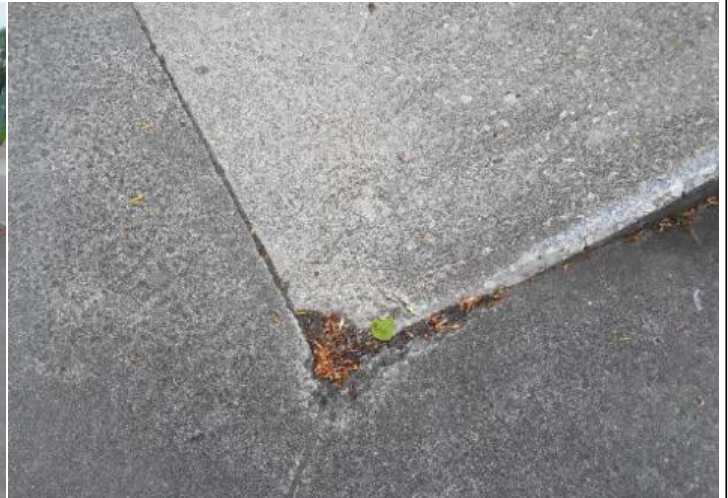
**Finding:** The riding surface of the ramp has some damage apparent

**Action:** Repair the affected areas

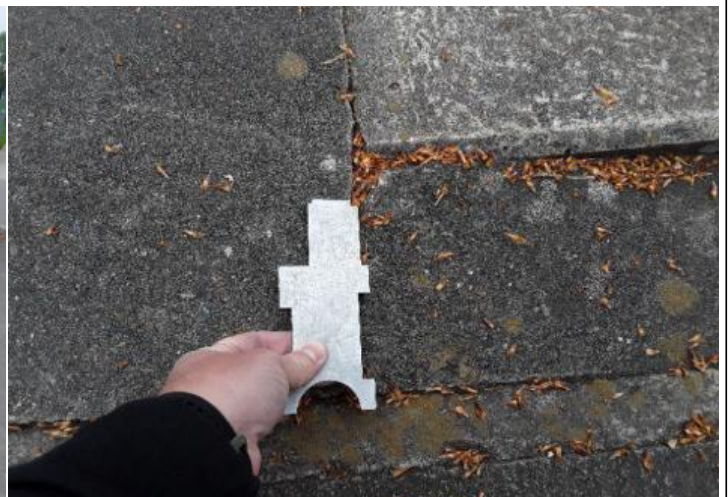
**Finding:** Joints between the riding surfaces should not be greater than 5mm to meet the requirements of BS EN 14974

**Action:** Take corrective action to ensure that the gaps between the joints do not exceed 5mm

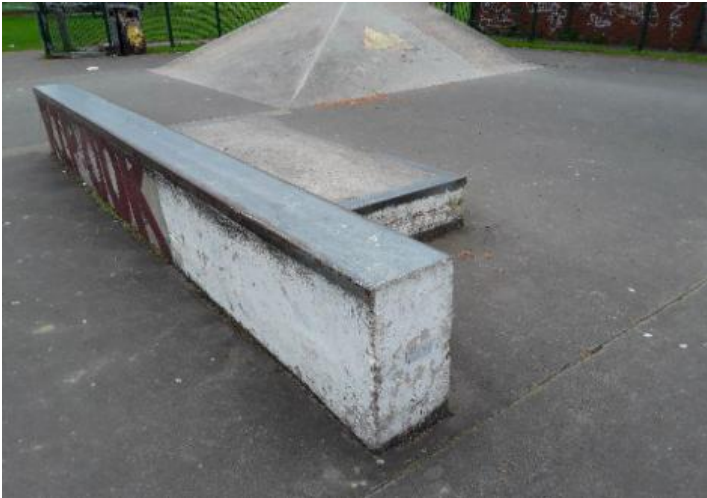
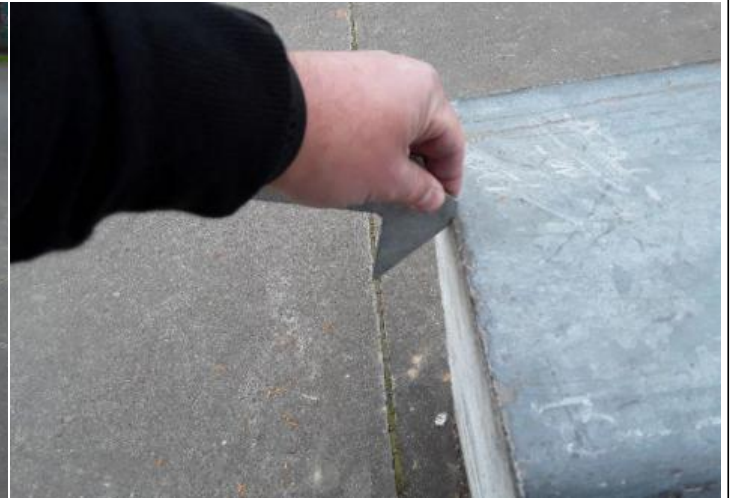
**Finding:** The item has exposed edges and corners with a radius of less than 3mm and fails the requirements of BS EN 14974

**Action:** Monitor - no remedial action recommended

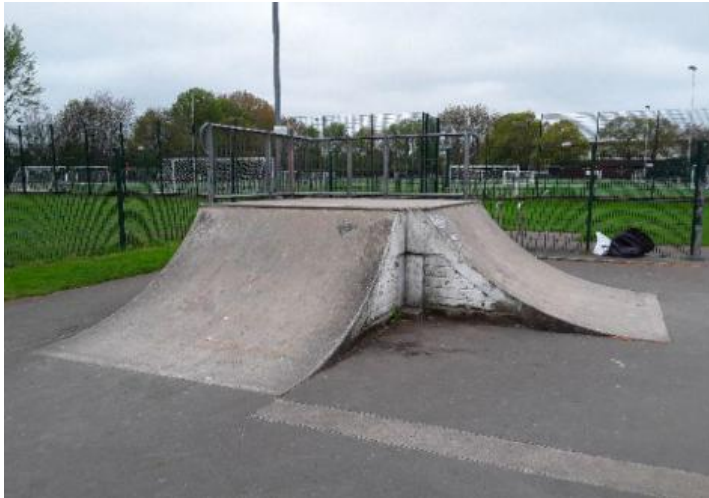
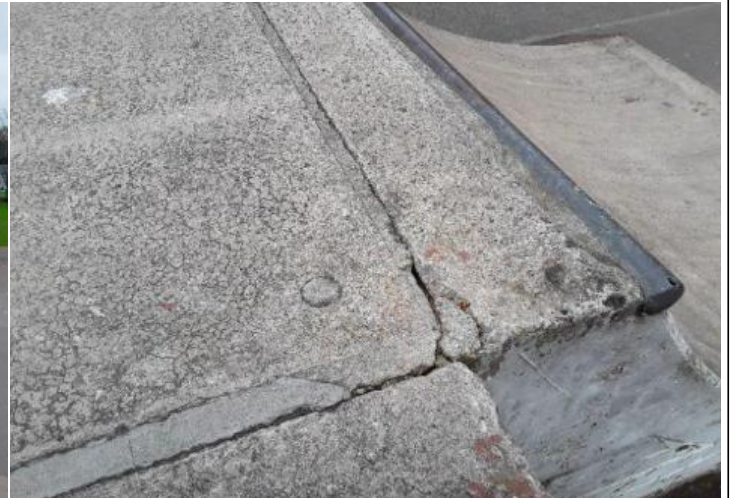
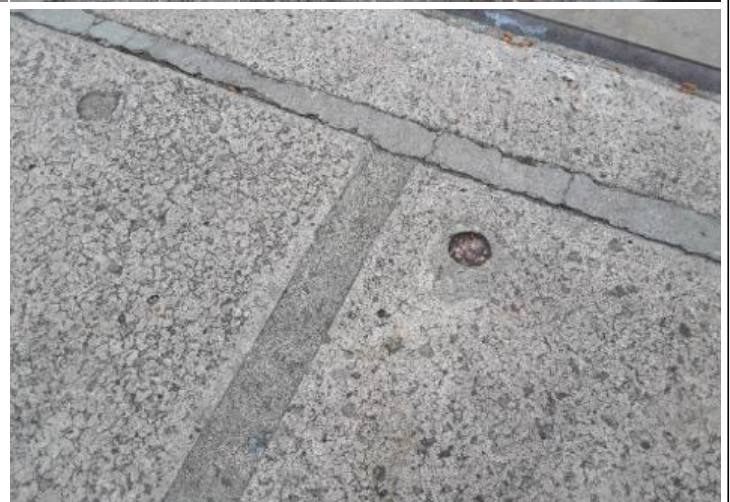
**Finding:** The riding surface of the platform has some damage apparent

**Action:** Repair the affected areas

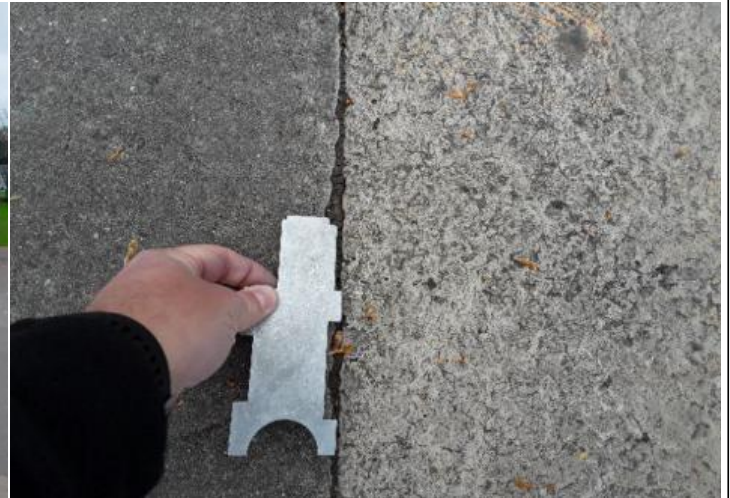
**Finding:** Joints between the riding surfaces should not be greater than 5mm to meet the requirements of BS EN 14974  
**Action:** Take corrective action to ensure that the gaps between the joints do not exceed 5mm

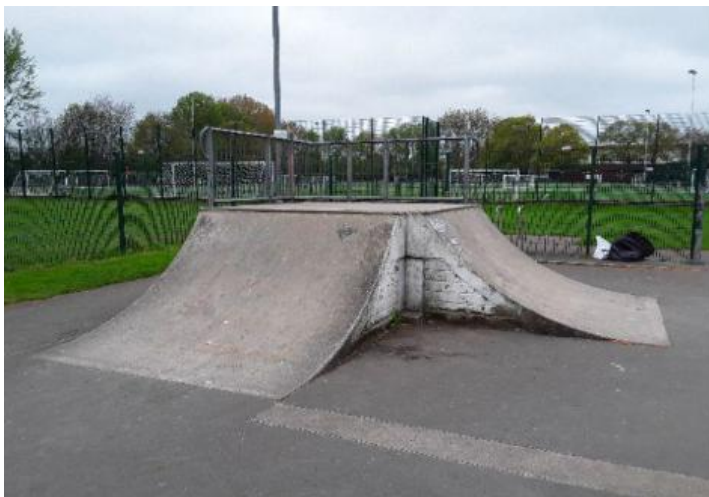
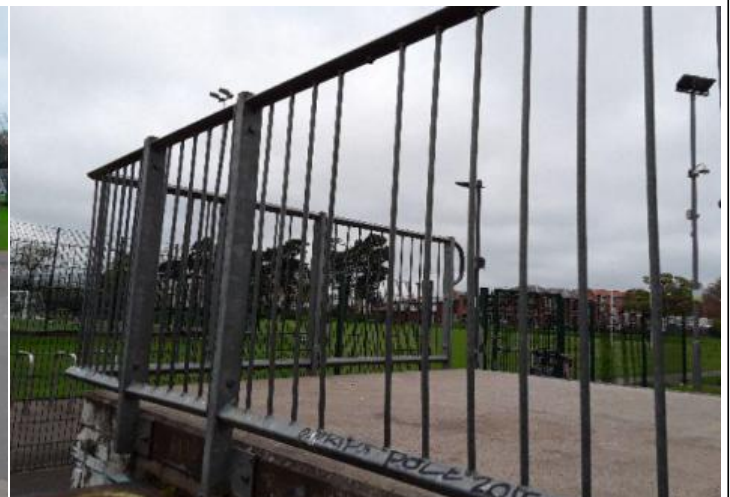
**Finding:** The barrier/s is/are severely damaged  
**Action:** Repair or replace

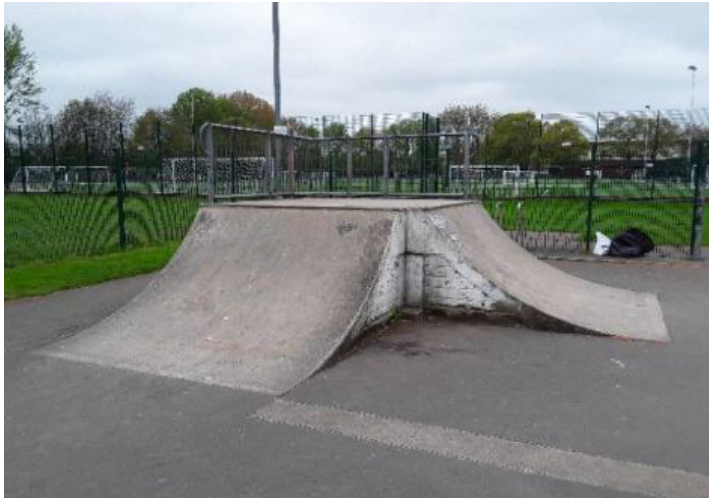
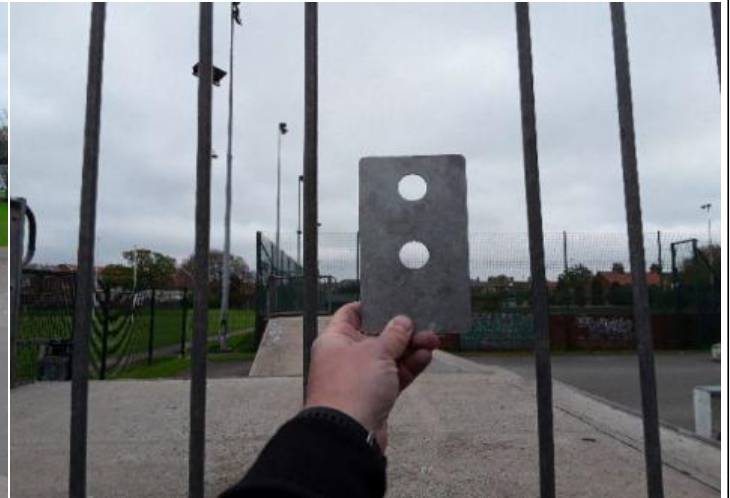
**Finding:** The horizontal opening in the barrier is in excess of 89mm and fails the requirements of BS EN 14974 **Action:** Repair the barrier
