## **Planning Environment and Services Committee**

Inspected: 4-May-2023 - 07:23 by Robert Walters RPII Annual Inspectors

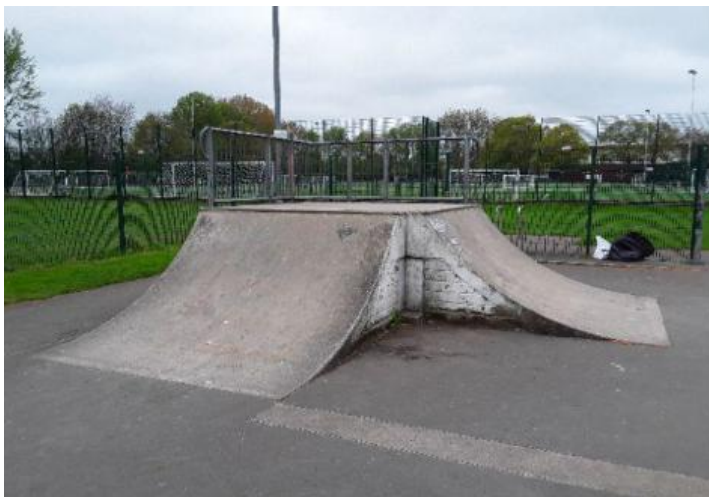
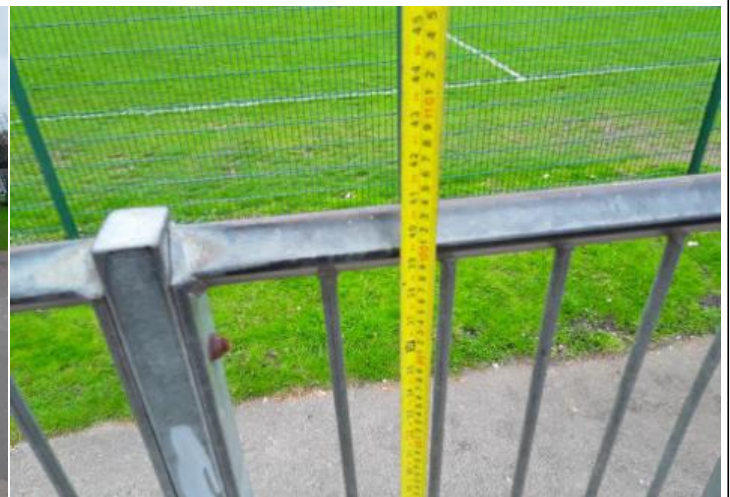
**Finding:** The height of the barrier is less than 1200mm and fails the requirements of BS EN 14974 **Action:** Monitor - No remedial work recommended
