## **Planning Environment and Services Committee**

Inspected: 4-May-2023 - 07:23 by Robert Walters RPII Annual Inspectors

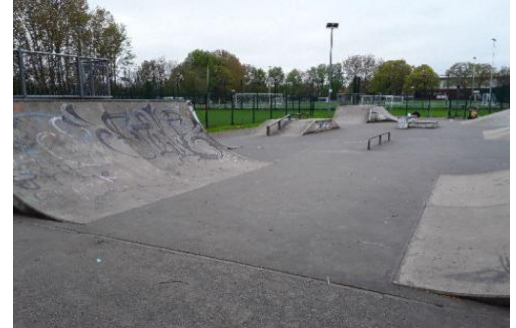
Signage of the wheeled sports area should be provided as recommended in BS EN 14974; this will include, but not exclusively, the use of the area, a recommendation to wear protective equipment, emergency contact details etc. - Provide signage as recommended by BS EN 14974 for wheeled sports areas

There is broken glass present on site - Remove the broken glass and maintain the area

There is damage to the brickwork - Repair affected areas

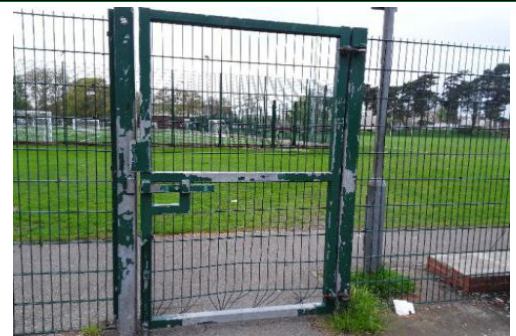
The gate is damaged in places - Repair or replace all affected sections

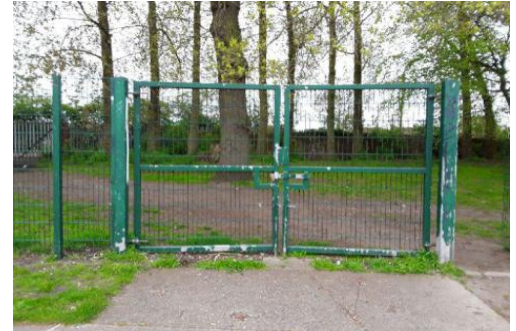
The gate has no drop bolt sleeves and/or drop bolts fitted - Provide drop bolt sleeves and/or drop bolts

There is some damage to the item - Monitor for any further deterioration and repair as required

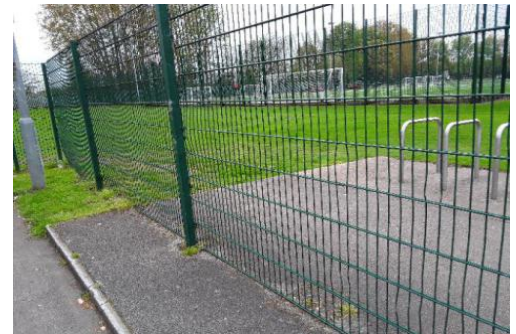
There are redundant cable ties present - Remove

There is some damage to the fence sections - Monitor for any further deterioration and repair as required

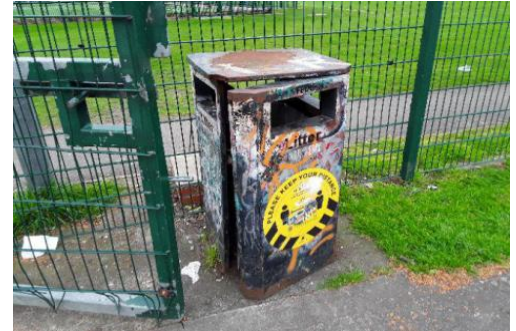
The lid or door of the litter bin is not secured - Ensure the lid or door is kept locked

There is some evidence of fire damage to the item - Monitor for any further deterioration and repair as required

There is some damage to the item - Monitor for any further deterioration and repair as required

There is surface corrosion present on the item - Consider treating the item

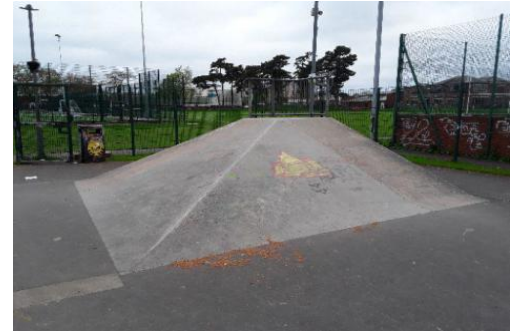
Joints between the riding surfaces should not be greater than 5mm to meet the requirements of BS EN 14974 - Take corrective action to ensure that the gaps between the joints do not exceed 5mm

The height of the barrier is less than 1200mm and fails the requirements of BS EN 14974 - Monitor - No remedial work recommended

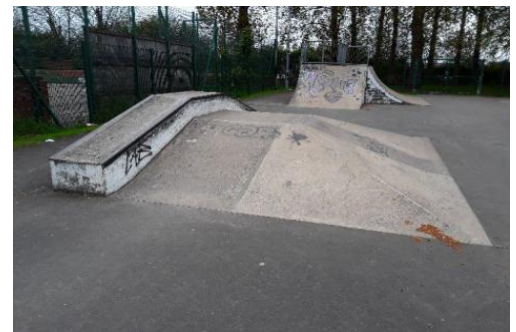
Joints between the riding surfaces should not be greater than 5mm to meet the requirements of BS EN 14974 - Take corrective action to ensure that the gaps between the joints do not exceed 5mm

The item has exposed edges and corners with a radius of less than 3mm and fails the requirements of BS EN 14974 - Monitor - no remedial action recommended

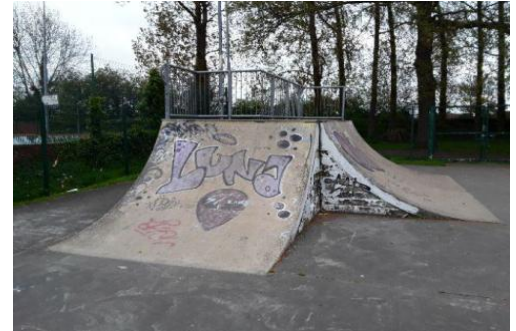
The height of the barrier is less than 1200mm and fails the requirements of BS EN 14974 - Monitor - No remedial work recommended

The coping has been damaged - Monitor for any further deterioration and replace as required

The riding surface of the platform has some damage apparent - Monitor for any further deterioration and repair as required

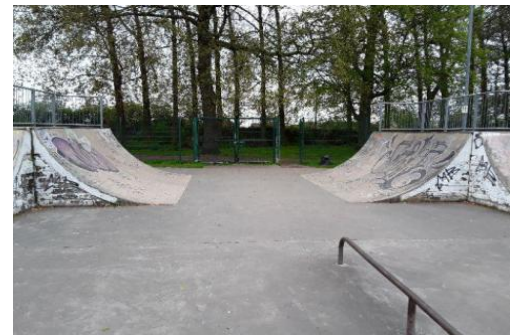
There are projecting bolt thread(s) present - Remove excess thread length and deburr or provide cap

The height of the barrier is less than 1200mm and fails the requirements of BS EN 14974 - Monitor - No remedial work recommended

The riding surface of the platform has some damage apparent - Repair the affected areas

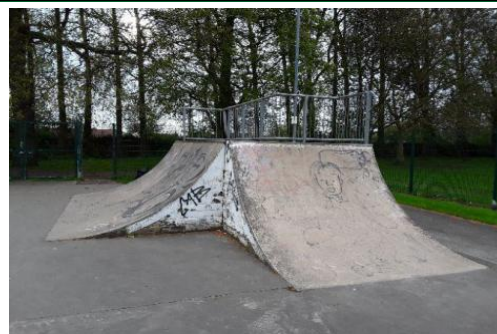
The height of the barrier is less than 1200mm and fails the requirements of BS EN 14974 - Monitor - No remedial work recommended

The riding surface of the platform has some damage apparent - Repair the affected areas

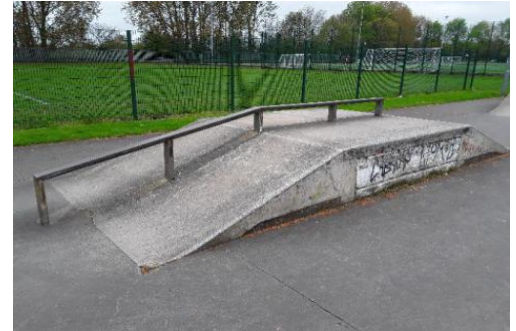
The riding surface of the ramp has some damage apparent  
- Repair the affected areas

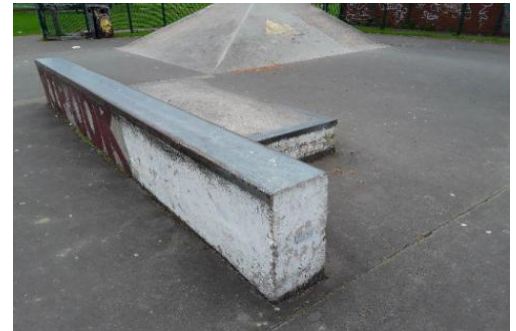
The item has exposed edges and corners with a radius of less than 3mm and fails the requirements of BS EN 14974 - Monitor - no remedial action recommended

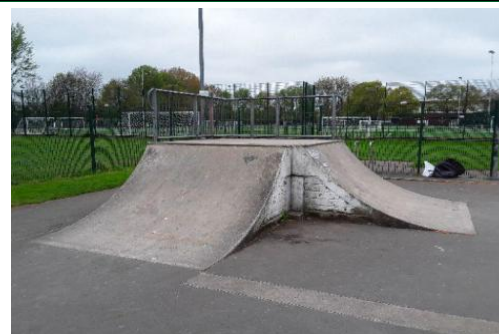
The riding surface of the platform has some damage apparent - Repair the affected areas

The barrier/s is/are severely damaged - Repair or replace

The height of the barrier is less than 1200mm and fails the requirements of BS EN 14974 - Monitor - No remedial work recommended

The horizontal opening in the barrier is in excess of 89mm and fails the requirements of BS EN 14974 - Repair the barrier
